# GAZA SOLID WASTE MANAGEMENT PROJECT (ADDITIONAL FINANCE RBF)

## JSC Quarter Annual Report: Environmental and Social Compliance

(January 2021 - March 2021)

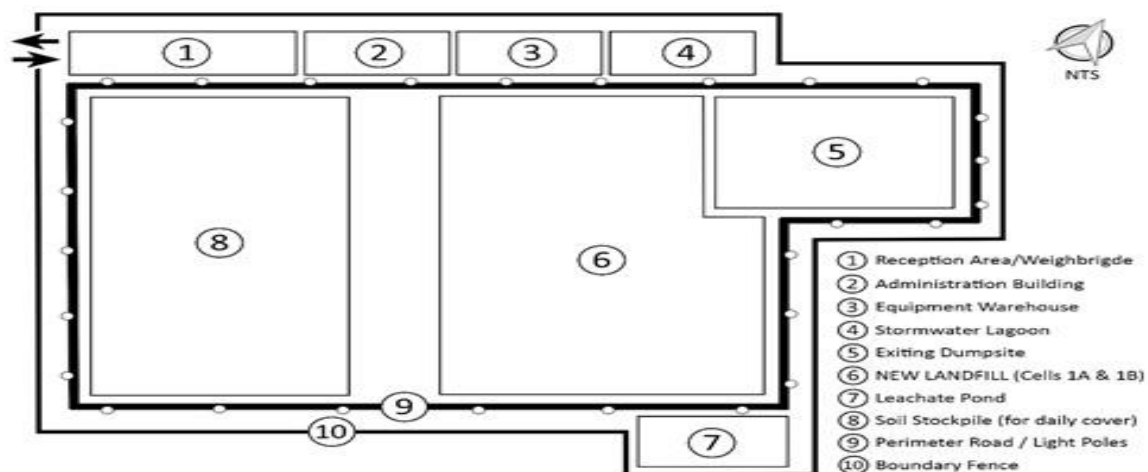
*Figure 1. Schematic of Sofa Sanitary Landfill in Al-Fukhari*

- Entrance area including weighbridge and control room;
- Building (190 m<sup>2</sup> on 3 levels) for JSC-KRM operation personnel staff;
- Maintenance Workshop (528 m<sup>2</sup>); Storm water drainage and storage pond (10,531 m<sup>3</sup> capacity);
- Disposal cell 1, divided in cell 1A and 1B (excavated up to 20 m below natural ground level), and slope 1:2 for sides with horizontal perm 5m width;
- Leachate pre-treatment (aeration lagoon, usable volume 6800 m<sup>3</sup>), it is excavated to 2.75 m below natural ground level;
- Peripheral road (length 1,735 m);
- Old Dumpsite (40,000 m<sup>2</sup>);
- Stockpile of excavated soil (85,000 m<sup>2</sup>); and
- Fence is surrounding all the site.

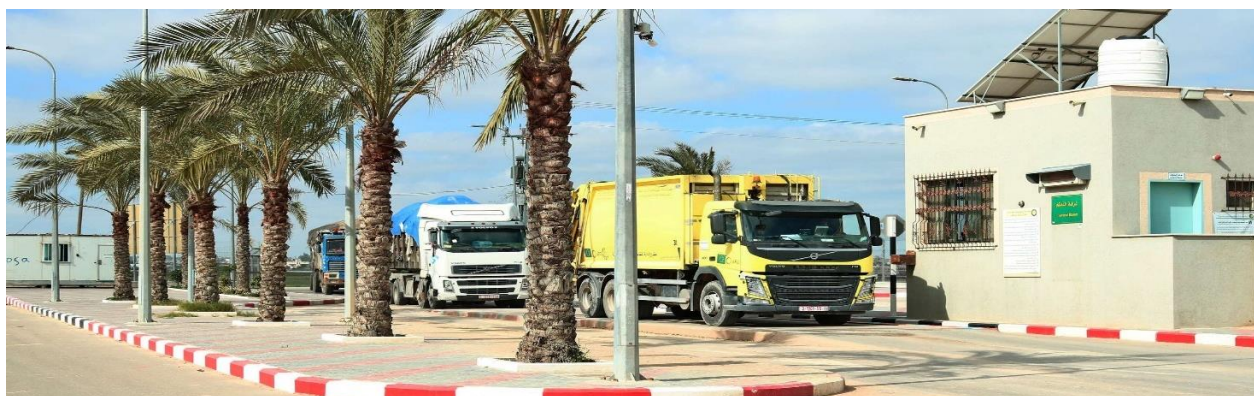
*Photo: Reception of Waste at Al-Fukhary Landfill*

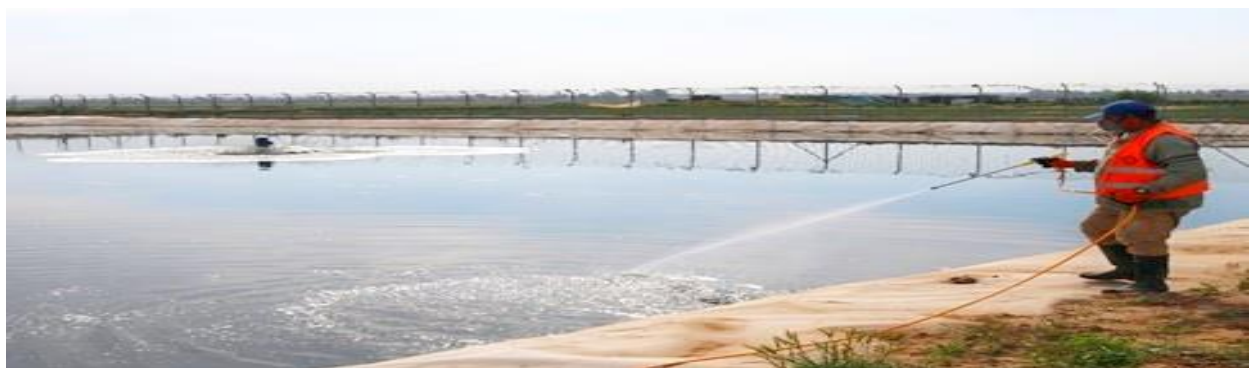
*Photo: Pest management of leachate lagoon*

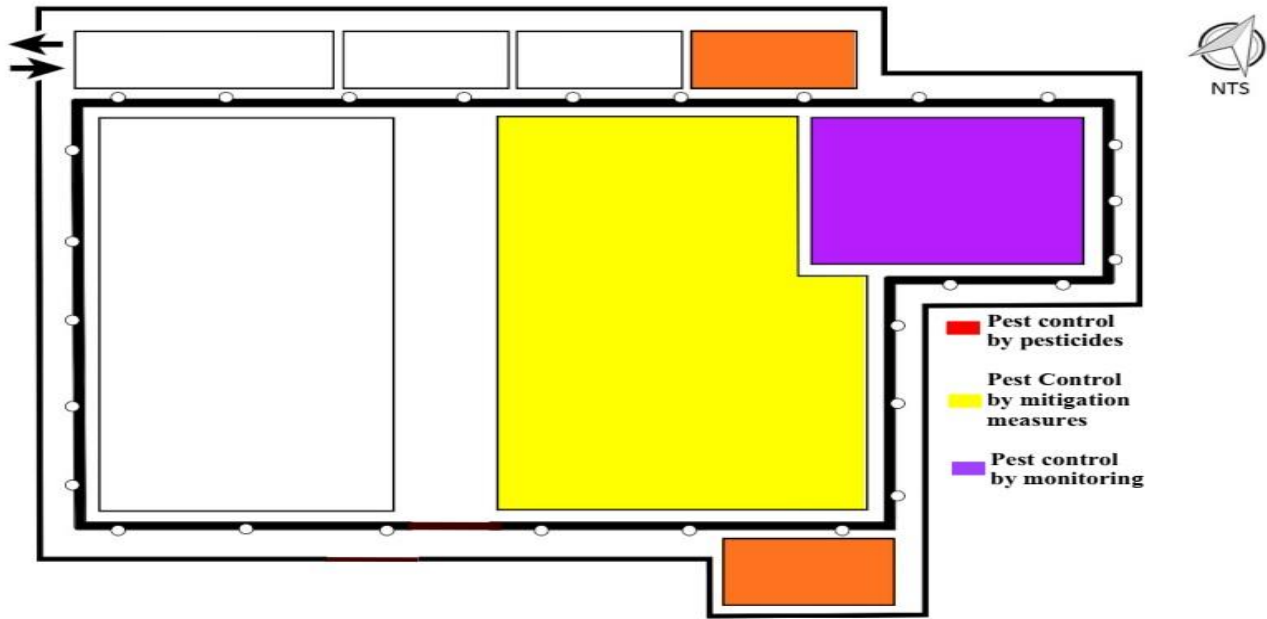
Figure 2. Levels of pest management at Al-Fukhary (Sofa) Sanitary landfill

A pest management plan has been prepared for Al-Fukhary Landfill during operation. The plan categories the source of pesticides and level of required measure as shown in Figure (2). Hence, the pest management time is associated with the pests breeding seasons which are mainly between April and October, so that there was no need to have any pest management activities during the reporting period as it is out of the breeding season.

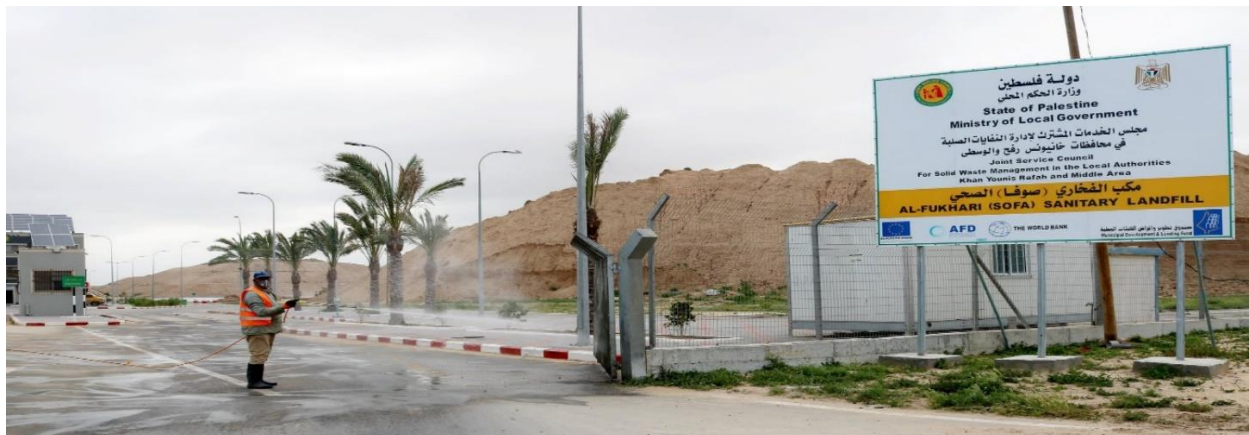
Photo: Sterilization of internal roads and facilities landfill

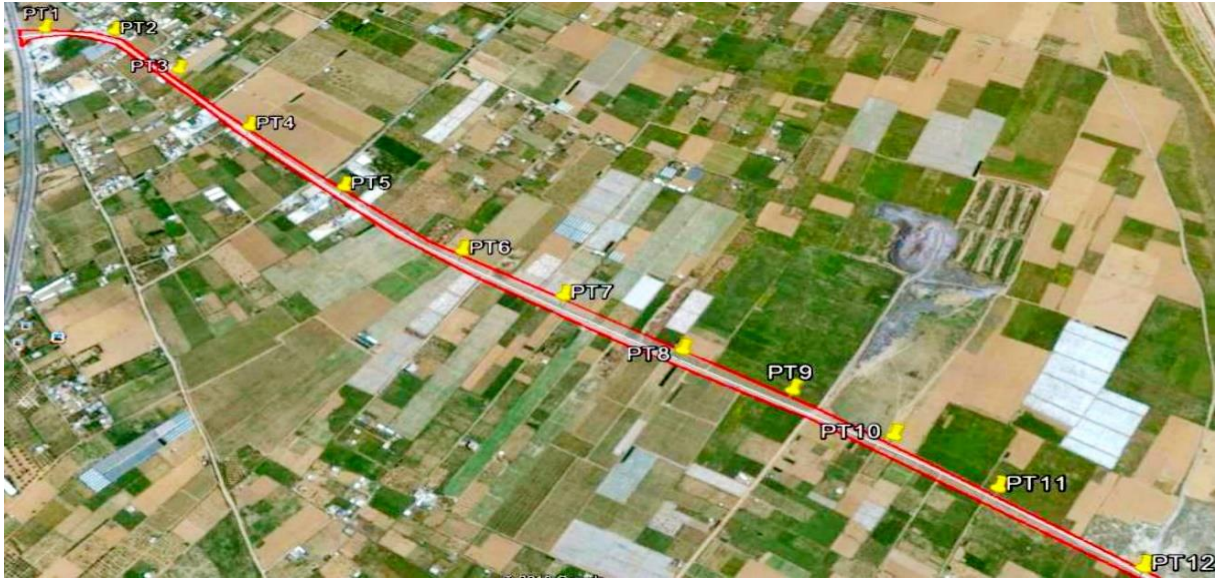
*Figure 9. Access Road layout*

Sofa road is used as access road to Sofa Solid Landfill, it has an access from Salah Al Dein Street and ends at the armistice borderline. Access road status is considered as not good due to the deep damage in large parts of its body. Figure (9) shows the location of the road. The length of the road is approximately 2.5 Km (from Salah Al Dein Street to the access gate of the landfill), knowing that the remaining length (from the access of the landfill to the borderline) will not be taken into account within this project. The width of existing access road varies from 4m to 6m in some parts.

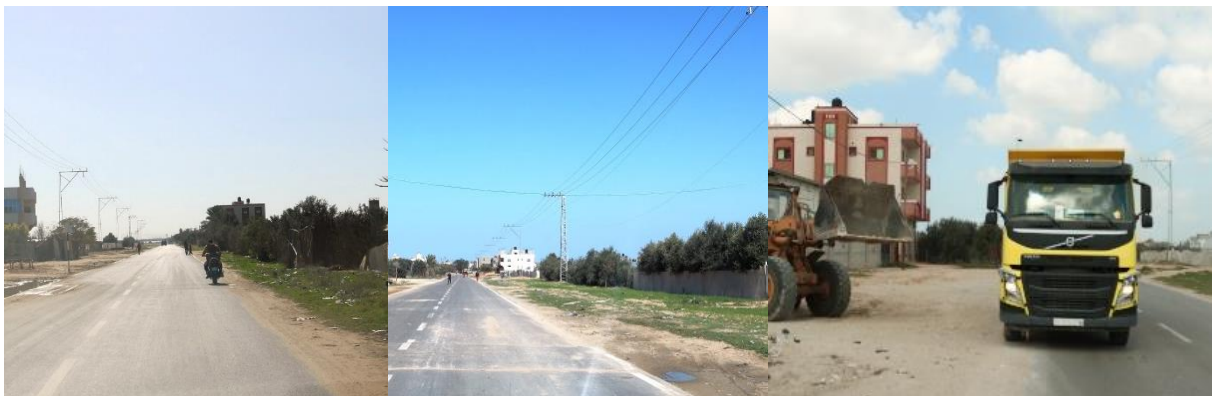
Improvements of the Sofa landfill access road were implemented. Such improvements consist of road widening in some narrow parts without removal of any trees, structures or infrastructures, and paving/rehabilitate of some damaged parts and expanding the pavement width up to 7.5 m, and final pavement cover were paved for all the road. Moreover, the rehabilitation included the cleaning of the access road from any dumped waste along the road.

*Photo: Sofa Landfill Access Road*
